**Flood Control Project Maintenance  
Levee Inspections**

**Fall 2018 Levee Maintenance Deficiency Summary Report**

**Sacramento River Basin**

| <b>RD0536</b> | Overall LMA Rating | Total LMA Miles | | | | | | |
|---|---|---|---|---|---|---|---|---|
| <b>Reclamation District No. 0536 Egbert</b> | <b>U</b> | <b>10.59</b> | | | | | | |

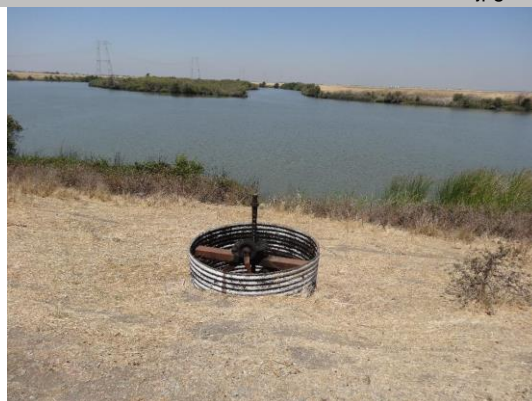
Photo 1 of 3 : UCIP\_FA\_2018\_20503\_34568.jpg

WS view: CMP riser with slide gate on levee slope. Water channel on background.

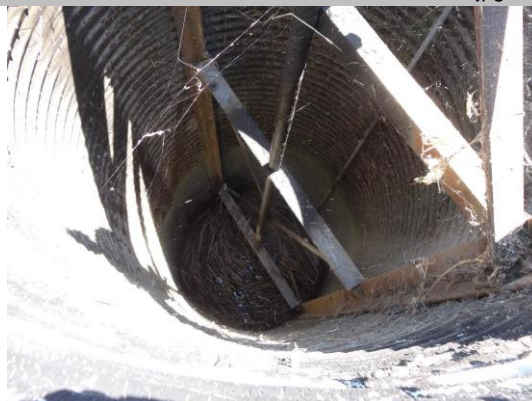
Photo 2 of 3 : UCIP\_FA\_2018\_20503\_34567.jpg

WS view: closer view of slide gate in CMP riser on levee slope.

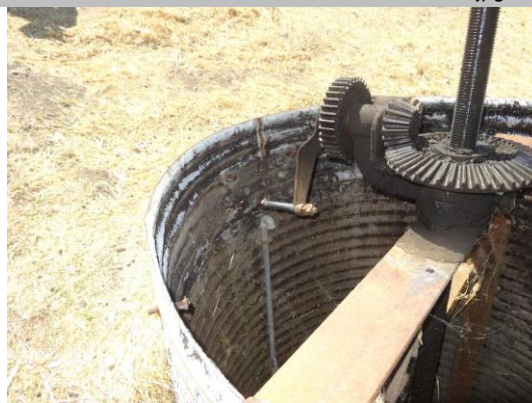
Photo 3 of 3 : UCIP\_FA\_2018\_20503\_34566.jpg

| FS_ID:20503<br>DS_ID:22718<br>EP_NO: 10116<br>Repair Type: No Action Needed<br>Crossing Status: Found<br>UCIP Comments: Vortex seen on WS. Water flow seen on LS.Saddle, apron, and headwall not visible. Inlet and outlet pipe-ends are submerged into water.<br>FIELD_STRUCT_DESC: 54-inch corrugated metal gravity drainage pipe through the levee, 30 feet below the crown. Screw gate in a pipe riser on the waterside (WS) slope. Saddle, apron, headwall, two corrugated metal cutoff walls, one No. 101 gate, and one No. 102 gate. (Retention of a 54-inch drainage pipe through the levee, 30 feet below the crown, and a slide gate on the WS slope authorized under Automatic Board Order (ABO) 10116, 1974 - Marion Sanchez Farms). [Additional Reference(s): DWR Levee Log, 1992. USACE Sacramento O&M Manual 106, May 1953, (Station 87+70 ""R""), invert elevation -2 feet].<br>FS Date: 8/13/2013 | | | | | | |

WS view: closer view of slide gate in CMP riser on levee slope. Air vent attached to the wall of CMP (left).

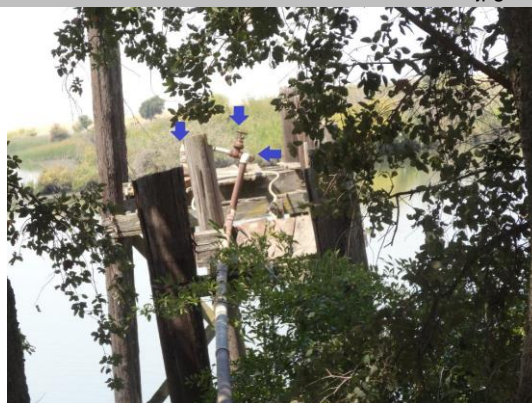
Photo 1 of 3 : UCIP\_FA\_2018\_49318\_34605.jpg

| FS_ID:49318<br>DS_ID:22720<br>EP_NO: 10116<br>Repair Type: Non-Urgent<br>Crossing Status: Found<br>UCIP Comments: 06/01/2016 Pipe is an abandoned crossing per conversation with district president David Hearn.Pipe seems to be abandoned.Catwalk and pumphouse on riverside not found. It is not clear whether the pipe pass through the levee or not. Needs more info from LMA/DWR Inspector.<br>FIELD_STRUCT_DESC: 3-inch galvanized irrigation discharge pipe through the levee, 4 feet below the crown. Catwalk and pump house on the waterside (WS). Concrete saddle and water tank on the WS slope. (Retention of a 3.5-inch pipe through the levee, 4 feet below the crown, concrete saddle, and water tank on the WS slope authorized under Automatic Board Order (ABO) issued as Permit No. 10116, 1974 - Marion Sanchez Farms). [Additional Reference(s): DWR Levee Log, 1992. USACE Sacramento O&M Manual 106, May 1953, (Station 33+16 ""R""), invert elevation 19 feet].<br>FS Date: 8/13/2013 | | | | | |

WS view: pump, pipe, gate valve, and wooden piling structure in the stream.

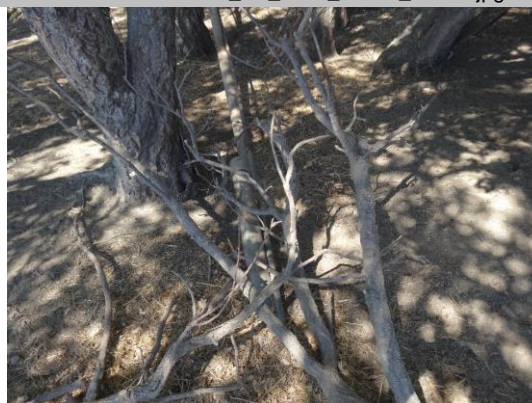
Photo 2 of 3 : UCIP\_FA\_2018\_49318\_34604.jpg

WS view: exposed pipes on levee shoulder.

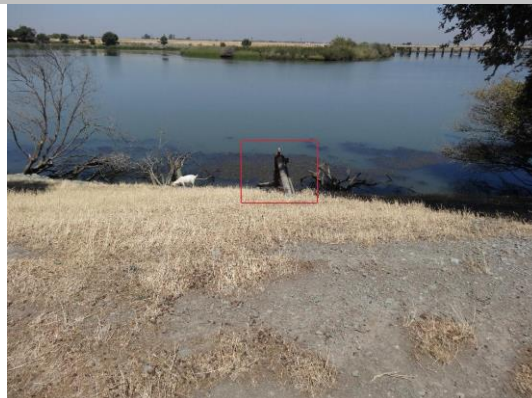
Photo 1 of 2 : UCIP\_FA\_2018\_49319\_35124.jpg

WS view: pipe and pump on channel bank.

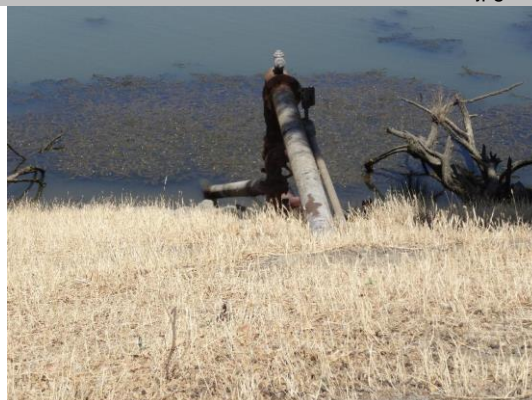
Photo 2 of 2 : UCIP\_FA\_2018\_49319\_35123.jpg

WS view: closer view of pipe and pump on channel bank.

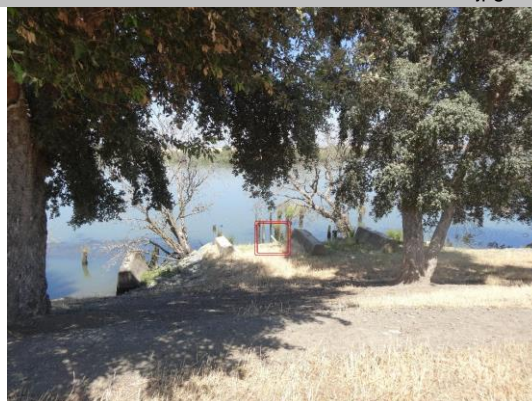
Photo 1 of 2 : UCIP\_FA\_2018\_20544\_34625.jpg

WS view: overview of levee slope, concrete pad, and pipe.

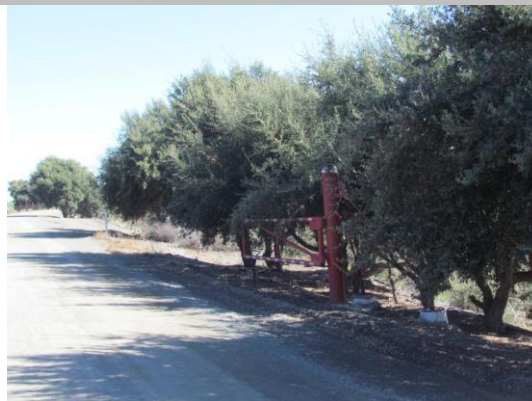
Photo 1 of 2 : FA\_2018\_RD0536\_208\_11\_20180924\_00001.jpg

This gate rest and gate on the landside of the levee shoulder.

| The District said that the property owner had this gate and barricade installed by the County. | | | | | | |

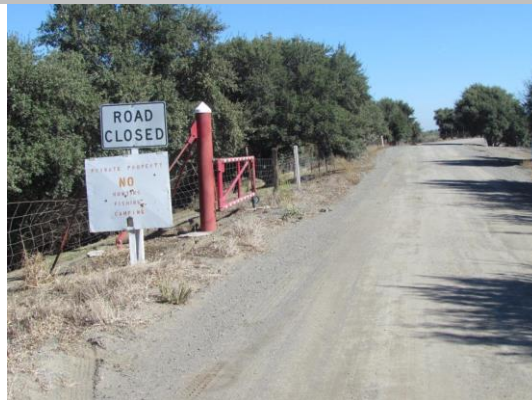
Photo 2 of 2 : FA\_2018\_RD0536\_208\_11\_20180924\_00002.jpg

RD 536 Unit 1 levee mile 5.34 waterside shoulder. No change. 4-17.

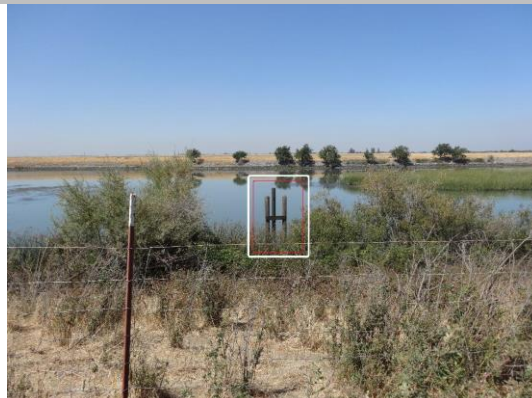
Photo 1 of 3 : UCIP\_FA\_2018\_20563\_34646.jpg

| FS_ID:20563<br>DS_ID:22722<br>EP_NO: 7208<br>Repair Type: Non-Urgent<br>Crossing Status: Found<br>UCIP Comments: - siphon breaker needs cover/protection.- service pole on landside of the levee.<br>FIELD_STRUCT_DESC: 30-inch steel drainage discharge pipe through the levee, 5.7 feet below the crown. Pump in a piling structure in a drainage ditch on the landside (LS). Siphon breaker on the waterside (WS) shoulder. (Plans to install a drainage pumping plant and 35 feet of 30-inch pipe through the levee authorized under Permit No. 7208, 1970 - Reclamation District No. 536 [RD0536]). [Additional Reference(s): DWR Levee Log, 1992].<br>FS Date: 8/13/2013 | | | | | | |

WS view: wooden & steel piles on the slough. Probably the supports are for pipe and flap gate. Not accessible due to fence.

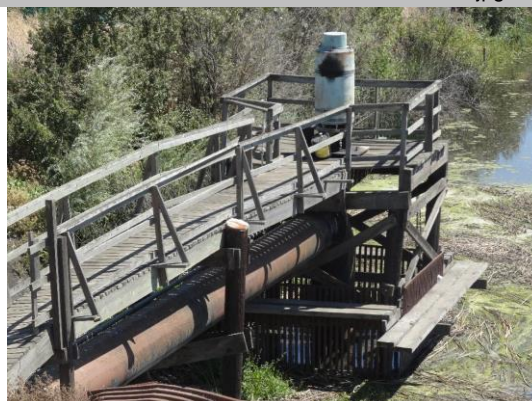
Photo 3 of 3 : UCIP\_FA\_2018\_20563\_34644.jpg

LS view: pipe under the wooden walkway and pump on wooden platform in drain ditch.

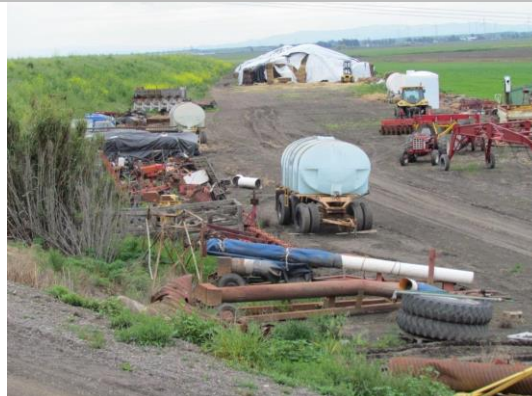
Photo 1 of 1 : FA\_2018\_RD0536\_209\_5\_20180924\_00001.jpg

RD 536 Unit 2 levee mile 0.09 landside toe.

| Remove the equipment from the landside easement levee miles 0.09-0.13. | | | | | |

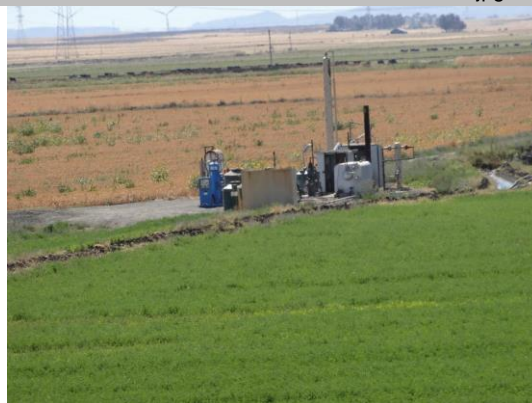
Photo 3 of 3 : UCIP\_FA\_2018\_20664\_34744.jpg

| FS_ID:20664<br>DS_ID:22732<br>EP_NO: 17829<br>Repair Type: Non-Urgent<br>Crossing Status: Indicator Found<br>UCIP Comments: Indicator is found only on WS. The indicator is different than standard indicator. Needs more info from LMA/DWR Inspector.<br>FIELD_STRUCT_DESC: 3.5-inch welded steel natural gas pipeline under the levee, 44 feet below the crown. (Plans to install a 3.5-inch welded steel natural gas pipeline bored under the levee authorized under Permit No. 17829, 2004 - Towne Exploration Company).<br>FS Date: 8/13/2013 | | | | | |

WS view: natural gas extraction plant near levee on the field.

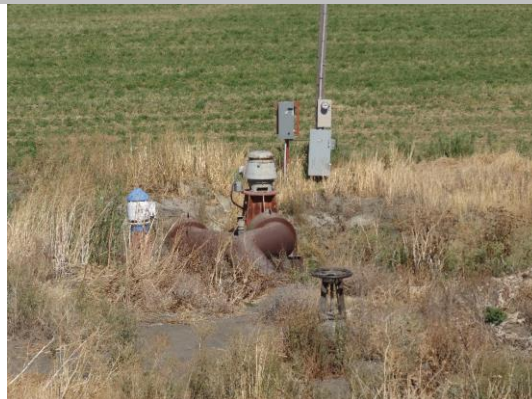
Photo 1 of 2 : UCIP\_FA\_2018\_20647\_34731.jpg

| FS_ID:20647<br>DS_ID:24025<br>EP_NO: N/A<br>Repair Type: Non-Urgent<br>Crossing Status: Found<br>UCIP Comments: Needs more info from LMA/DWR Inspector. Pump and pipe looks new.<br>FIELD_STRUCT_DESC: 12-inch steel irrigation discharge pipe with vertical pump on the drainage ditch. No other details available. This crossing was field discovered.<br>FS Date: 8/13/2013 | | | | | |

WS view: overview of pipe and pump (left). Big pump and appurtenances (right) for 24" steel pipe.

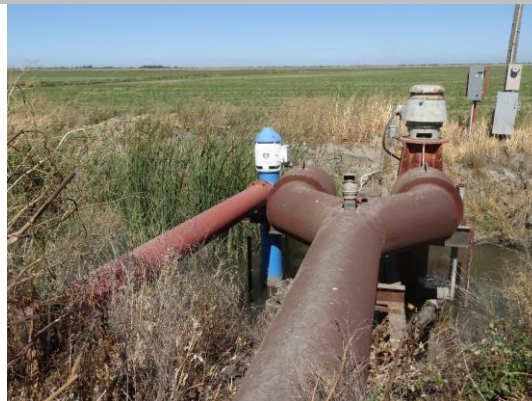
Photo 2 of 2 : UCIP\_FA\_2018\_20647\_34730.jpg

WS view: closer view of pipe and pump (left). Big pump and appurtenances (right) for 24" steel pipe.

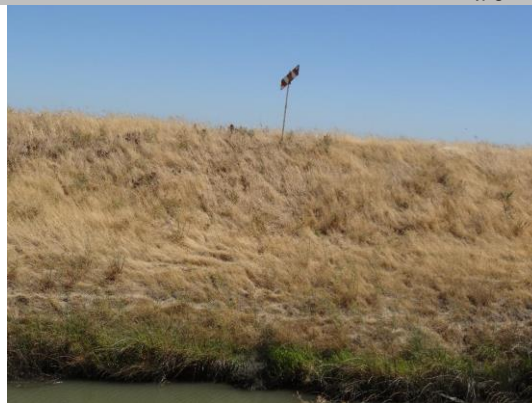
Photo 1 of 2 : UCIP\_FA\_2018\_41845\_34765.jpg

WS view: gasline indicator across the channel.

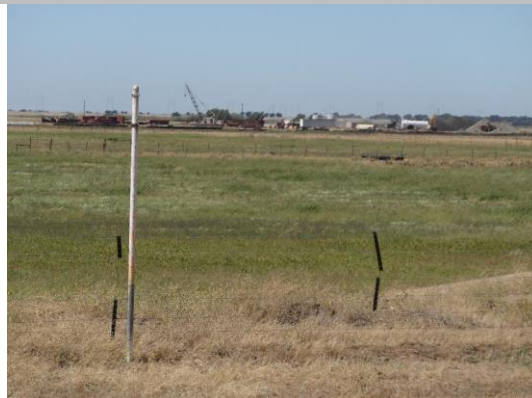
Photo 2 of 2 : UCIP\_FA\_2018\_41845\_34764.jpg

| FS_ID:41845<br>DS_ID:22731<br>EP_NO: 1217<br>Repair Type: Non-Urgent<br>Crossing Status: Indicator Found<br>UCIP Comments: Gasline needs markers on both slopes. Existing markers in disrepair.<br>FIELD_STRUCT_DESC: 8.625-inch natural gas pipeline of an unknown material through the levee, at an unknown depth. (Plans for installing an 8.625-inch natural gas pipeline crossing authorized under Permit No. 1217, 1947 - Pacific Gas and Electric Company [PG&E]). [Additional Reference(s): DWR Levee Log, 1992].<br>FS Date: 8/13/2013 | | | | | | |

LS view: gasline indicator on levee toe.

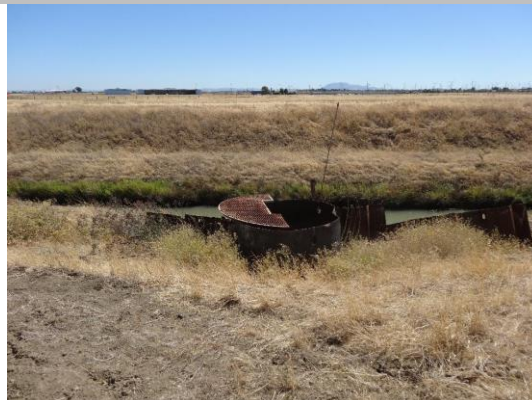
Photo 1 of 3 : UCIP\_FA\_2018\_46813\_34768.jpg

| FS_ID:46813<br>DS_ID:22735<br>EP_NO: N/A<br>Repair Type: Non-Urgent<br>Crossing Status: Found<br>UCIP Comments: Recommend owner contact CVFPB to provide updated owner info and obtain necessary permit for this crossing.<br>FIELD_STRUCT_DESC: 18-inch steel drainage pipe through the levee, at an unknown depth. Steel standpipe on each side of the levee.<br>Temporary canvas about 2 inches below the crown. Per 2015 Inspection Report provided by Herman Phillips, a diesel motor was found on the waterside (WS), and the owner is Mr. Page Baldwin. This crossing was field discovered.<br>FS Date: 8/13/2013 | | | | | | |

WS view: steel standpipe on levee slope.

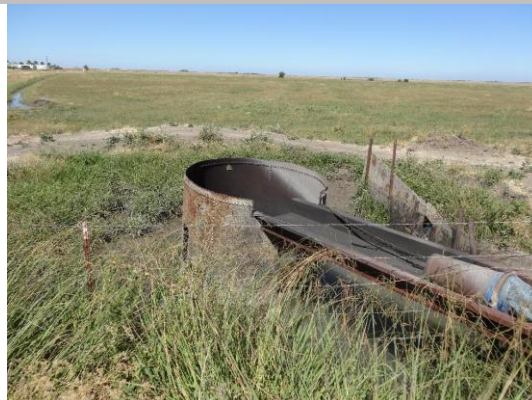
Photo 2 of 3 : UCIP\_FA\_2018\_46813\_34767.jpg

LS view: steel standpipe on levee slope.

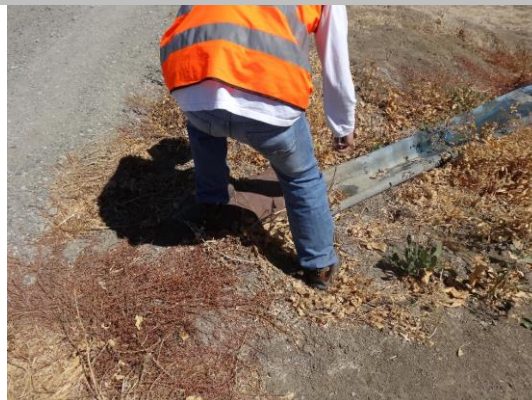
Photo 3 of 3 : UCIP\_FA\_2018\_46813\_34766.jpg

WS view: steel pipe on levee shoulder at 2-inch below the crown.
